ERDC/CERL TR-06-14

# **Evaluation of Soil Loss and Erosion Control Measures on Ranges and Range Structures at Installations in Temperate Climates**

## **Final Report**

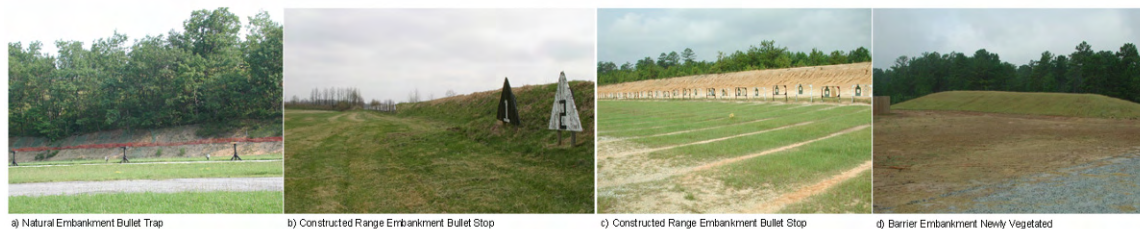
**Figure 1. Stop berms.**  
**(a) natural (b) aged (c) heavily eroded (d) revegetated.**

With the exception of the far right embankment (d), the berms in Figure 1 contain areas of extensive localized erosion. On these embankments, localized erosion is the result of repeated military ordnance impact; the severity of erosion intensifies with higher training frequency. The embankments in Figure 1(a) and 1(c) exemplify poorly maintained and heavily used embankments in service less than a decade. The embankment of Figure 1(b) represents a highly used, well-maintained embankment in service over several decades. Clearly, embankment maintenance practices have a great potential to reduce environmental risk. Embankment disturbance and subsequent soil movement have increased environmental risk for

embankments in Figure 1(a) and 1(c). Mitigating topsoil disturbance from weapons impact is a significant maintenance challenge as vegetation reestablishment is difficult on the remaining eroded nutrient-poor soil.

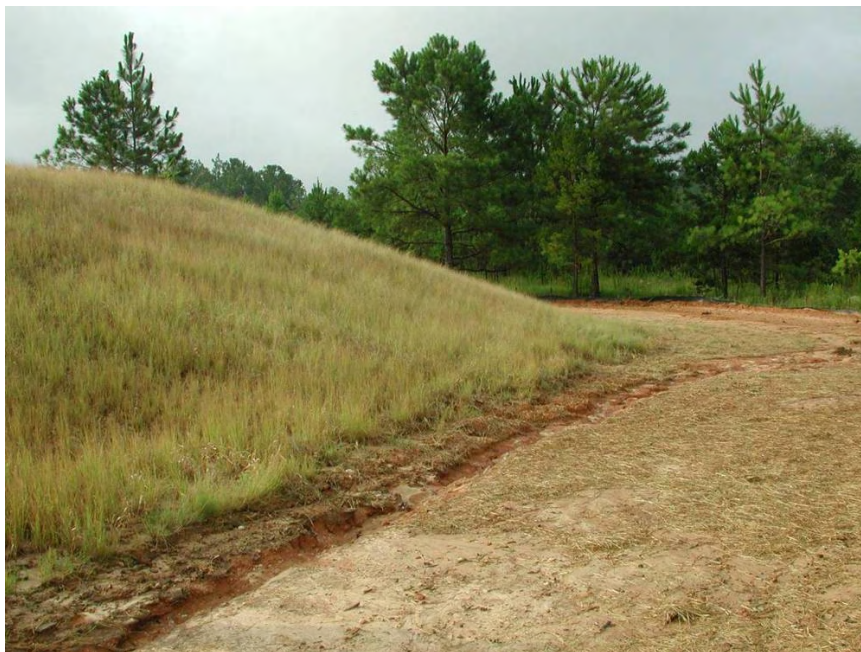
Investigations of newly constructed embankments as in Figure 2 revealed another problem at several training areas. Frequently, range soil conservation efforts concentrate on the range structure, but fail to encompass the surrounding areas. Embankment construction changes the local hydrological characteristics creating potential stresses on the surrounding watershed. The embankment in Figure 2 exhibited rill formation at the embankment toe and substantial erosion of the adjacent area. Embankment toe undercutting reduces berm stability and may cause embankment failure. Furthermore, the soil lost from this area increases environmental risk in locations down gradient of the embankment.

Figure 2. Newly revegetated embankment with severe toe erosion.

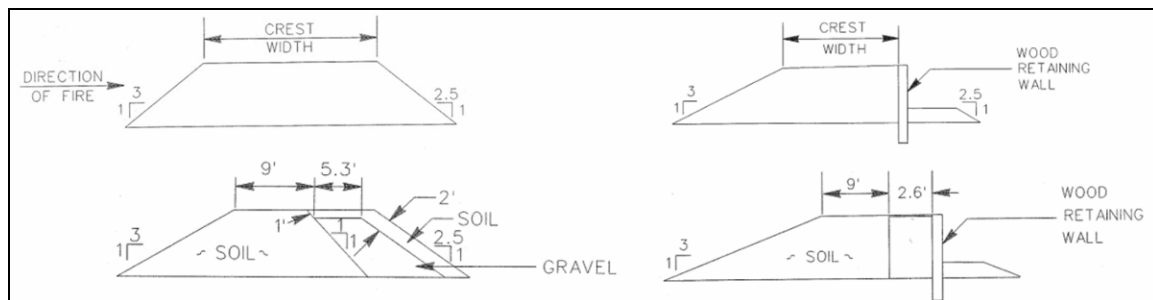
The orientation of multiple firing points in angle, height, and distance to multiple targets situated throughout a range is a critical design component. The positioning of firing and target emplacements are outlined in the *RETS Range Design Manual*. Four embankment design types specified in the design manual protect target and firing structures from damage as seen in Figure 3.

**Figure 3. Embankment design variations for ranges.**

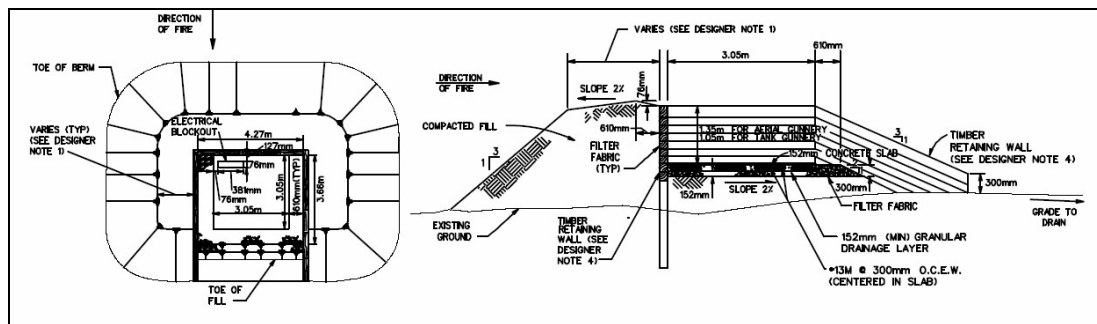
Stationary emplacements are present on small ranges as infantry target emplacements, and on larger ranges as both armor target emplacements and infantry target emplacements. Review of the *RETS Range Design Manual* regarding stationary target emplacements indicated several design issues requiring further scrutiny. Embankment slope, embankment face composition/erosion control, and emplacement profile guidelines were found to be inadequate or nonexistent. This finding was based on 30 stationary target inspections and numerous design critiques. Figure 4 shows typical stationary target emplacements. Appendix A contains the complete design.

**Figure 4. Stationary target design for armored vehicles.**

The design manual recommends an embankment slope of 3:1 and requires a geotechnical investigation to justify the use of lesser slopes. During embankment inspections at Fort Benning and Fort Drum, the research team observed slopes steeper than the design specification of 3:1. Many of these embankment slopes had extreme erosion problems. Embankment inspections at Camp Atterbury indicated that surface soil conditions (see Appendix B for further details on Camp Atterbury soils) necessitated a design slope of 4:1 or the installation of erosion control structures. Nonetheless, a 3:1 slope was constructed, which continually presents a maintenance challenge. When done correctly, determining embankment slope design criteria requires an assessment of soil parameters, maintenance requirements, and area hydrology. Employing a conservative range design strategy with adequate slopes will ease future maintenance requirements and cost less over the long term.

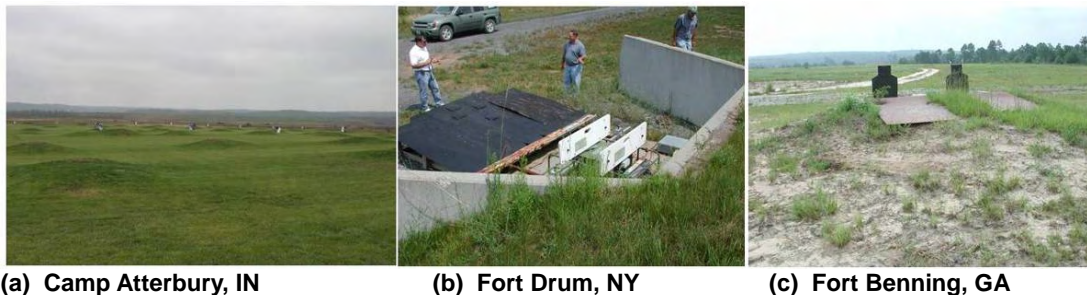
Erosion on stationary target embankments is the result of inadequate design, infrequent range maintenance, and high training use. The sparsely vegetated embankment of Figure 5(c) typifies emplacements under such conditions. Initially, vegetation cover in Figure 5(c) was similar to that of Figure 5(a). In this instance, berm soil loss from the embankment top produced subsequent problems near the bottom of the embankment. A lack of near-surface embankment stabilization techniques

contributed greatly to the deteriorated conditions of the far right image in Figure 5(c).

(a) Camp Atterbury, IN

(b) Fort Drum, NY

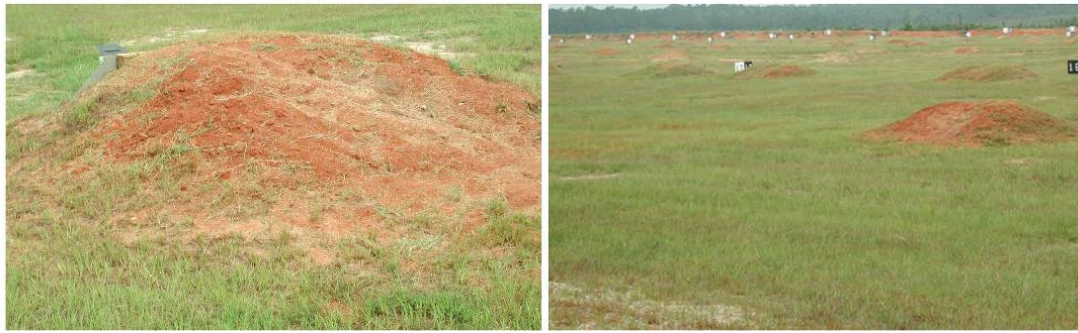
Figure 6 depicts heavily used embankments exhibiting pattern erosion on the embankment face. The ability of a berm to recover from pattern erosion largely depends on the soil type, the established vegetation, the amount of range training activity, and the embankment maintenance interval. Weapon fire initiates pattern erosion on stationary targets, removes vegetation from the topsoil, and changes aggregate topsoil mixture through impact. Embankment observations demonstrated that well-established ground cover and gradual slope angles limited the effects of pattern erosion. For example, stationary embankments with slopes of 5:1 and 6:1 had noticeably less pattern erosion and soil loss on the embankment face than stationary embankments with slopes of 3:1. Two factors explain this phenomenon: the change of ordnance impact angle and the reduction of soil movement potential. These two factors limited slope damage and erosion, allowing a better opportunity for vegetation persistence and recovery. Incorporation of these factors into the design criteria will enable longer maintenance intervals and improve the embankment profile. Additionally, lesser slopes provide an improved training target by reducing the embankment profile.

**Figure 6. Stationary infantry target emplacement pattern erosion.**

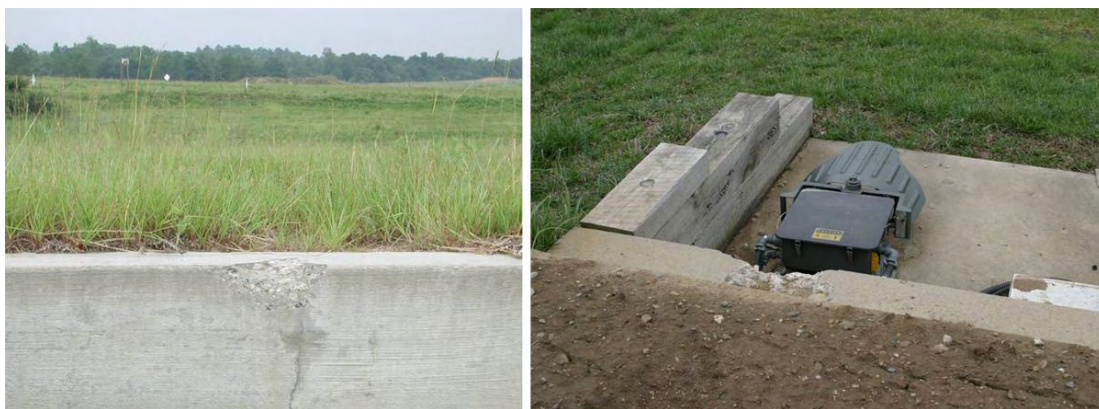
The earthen embankments protect the target superstructure from ordnance damage. Yet damage to the target superstructure does happen. For example, Figure 7 shows damaged retaining walls. This damage, though ostensibly superficial, has shortened the useful lifespan of the structure. The cyclic processes of freezing and thawing will eventually take their toll and hasten degradation over time. This problem is preventable and opportunities exist to circumvent this problem using a combination of materials. The *RETS Range Design Manual* specifies the use of wood rail ties with filter fabric. An allowable design substitution is concrete. The research team found that alternative materials such as geo-textiles were being used at several installations in the construction of stationary target superstructure walls. Review of the design guidelines brought to light deficiencies in the use of wood and concrete. Wood rail ties, although cheap and effective, have a shorter useful design life than concrete. Concrete is durable and long lasting, yet susceptible to impact damage. The shorter lifespan of wood rail ties is a potential problem during routine target rehabilitation. The removal of the ties disturbs the compacted subsoil possibly compromising berm integrity on smaller emplacements. Optimum combinations of wood, concrete, and geo-textiles require further investigation to prolong retaining wall life and reduce the potential for ordnance damage.

**Figure 7. Retaining wall damage on a stationary target emplacement.**

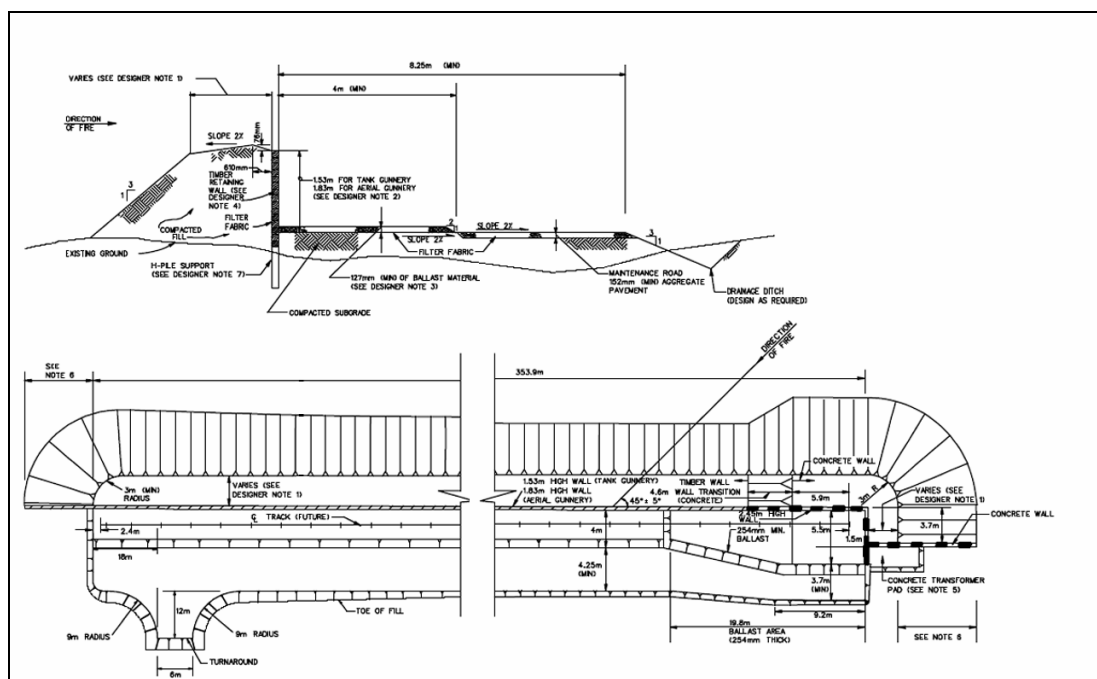
Moving target embankments are used extensively on multipurpose training ranges, multipurpose range complexes, and tank gunnery ranges. They are used to protect armor target emplacements and are one of the largest structures constructed on a training facility. Figure 8 shows the design guidelines for this structure; Appendix A shows the complete design.

Figure 8. Moving target design for armored vehicles.

Scrutiny of the moving target design guidelines and the drawing specifications in the *RETS Range Design Manual* found several items warranting further analysis. The design weaknesses of moving target emplacements are similar to stationary target emplacements and have been discussed in the previous sections. As with stationary target emplacements, embankment slope dimensions, embankment face composition, berm erosion control methods, emplacement profile restrictions, and target emplacement superstructure were analyzed and deficiencies were noted.

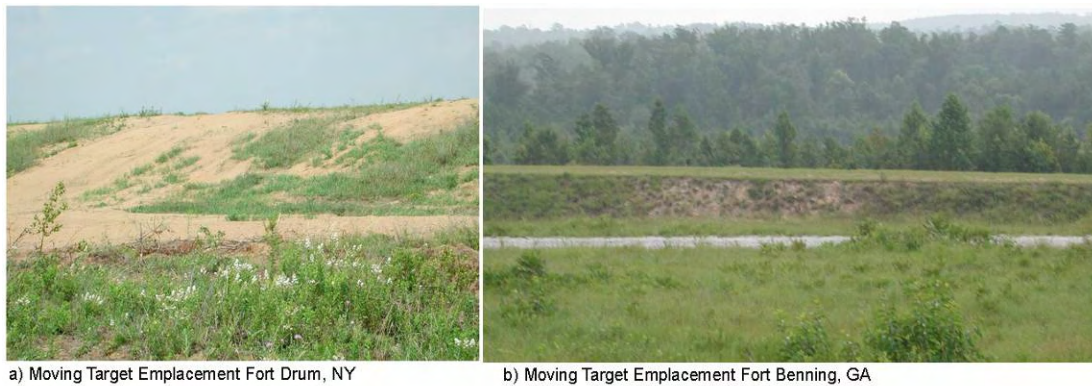
Typical moving target emplacements are shown in Figure 9. Note the erosion on moving target berms.

**Figure 9. Typical moving target berms.**

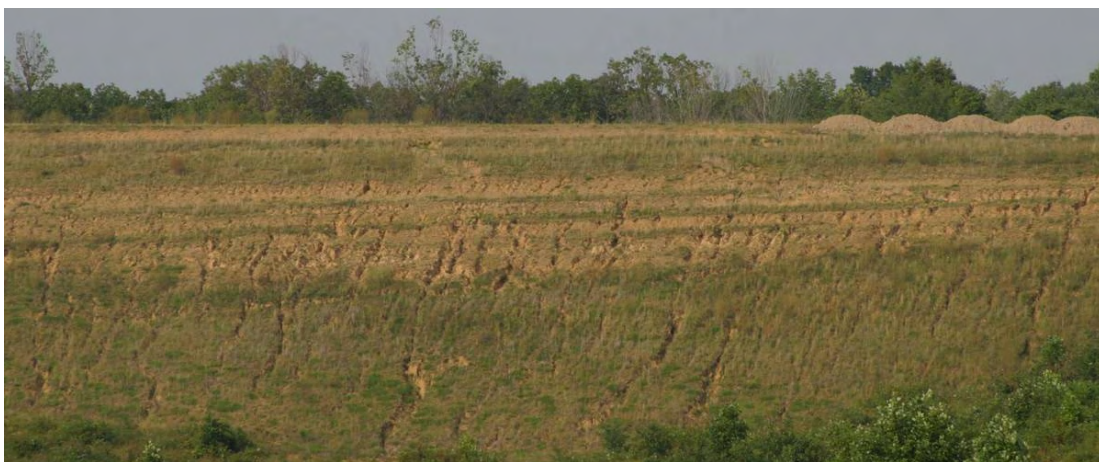
Slope dimensions were the first design criteria analyzed for moving target berms. Slope angle was discussed as a design issue during the analysis of stationary targets; moving target emplacements follow the same criteria. Slope angles of moving target embankments were examined at each installation visited. The slope angles appeared to follow the design criteria. Several were measured to validate compliance and were found to be in the range of 3:1 to 4:1. At Camp Atterbury, the largest embankment on a multi-purpose training range had a side slope of 3.2:1. The erosion of Figure 10 shows this slope to be insufficient for the soil type. Berm thickness, as with stationary target emplacements, seemed to be satisfactory at every installation.

**Figure 10. Moving target embankment erosion.**

Referring again to Figure 10 as an example, slope length was determined to be a more critical issue on moving target emplacements than stationary target emplacements. When ranges are placed in areas of high relief and berms are built to ac-

commodate line-of-sight constraints, slope length erosion problems increase as the height of the embankment increases. Slope length guidelines and erosion control techniques are essential to prevent the erosion shown in Figure 10. Related to slope length is embankment height; line-of-site analysis requires that embankments provide a direct visual line from the firing point to the target. On large ranges, this requirement often dictates that target emplacements at the end of the range be substantially higher than emplacements near the beginning of the range; limitations on berm height in conjunction with slope length are recommended. Furthermore, additional emphasis on erosion control and embankment stability is required on berms that are more elevated.

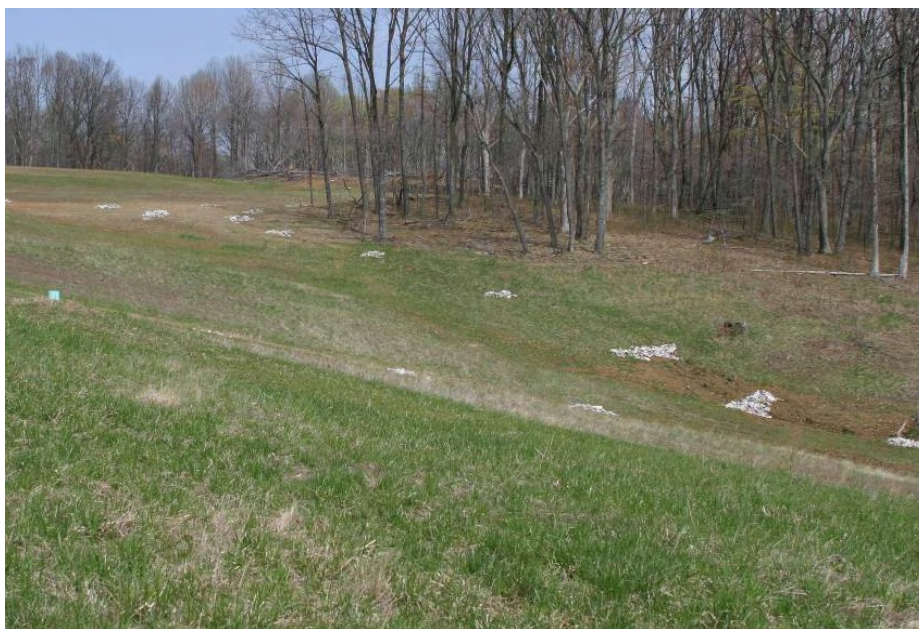
During installation visits it was noted that few erosion control measures were in place on any of the embankment faces or in the surrounding drainage outlets. Occasionally rock check dam structures were used in the drainage areas surrounding the berm (see Figure 11). The use of rock check dams was not a common practice except on the MPTR at Camp Atterbury where a lack of vegetation was causing severe rill and gully erosion in the waterways. One range at Fort Benning did have erosion control measures in place: rock-lined waterway channels and riprap embankments. None of the visited installation used surface roughening techniques, runoff containment structures, or embankment land formations that would suggest an effort to control runoff on or near the embankment face. The range design guidelines do not specify requirements for erosion control.

**Figure 11. Rock check structures in use at Camp Atterbury, IN.**

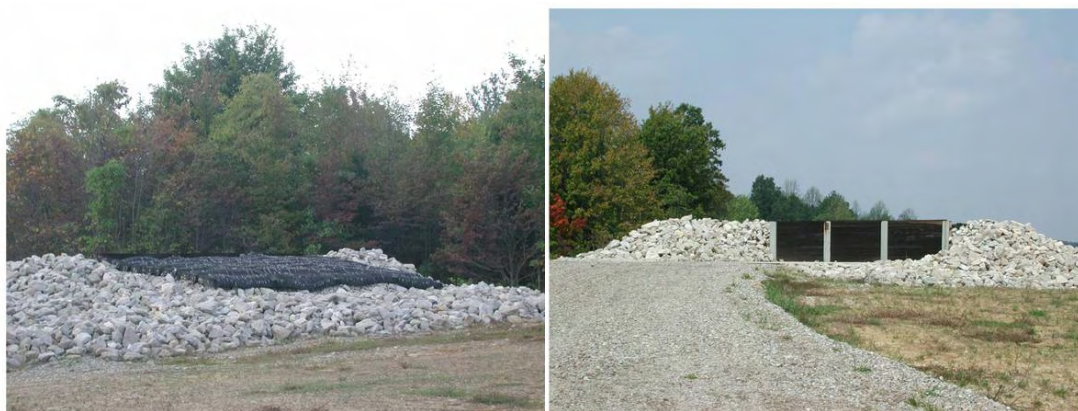
The defilade design utilizes rock riprap to stabilize the embankment and reduce erosion/dust generated by the blast wave. The image on the left-hand side of Figure 13 illustrates a blast mat to protecting riprap. The image on the right-hand side of Figure 13 illustrates the defilade superstructure. The merits of the three defilade designs and the material specifications contained within the *RETS Range Design Manual* follow.

**Figure 13. Defilades at MPTR, Range 37, Camp Atterbury, IN.**

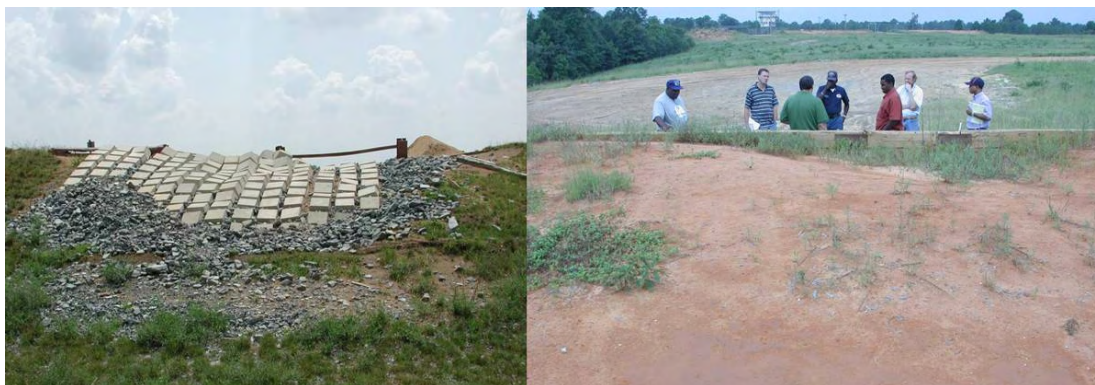
Many defilades were inspected during the installation visits. The defilades at Camp Atterbury were found to be in the best condition as this range was relatively unused at the time of inspection. The research team observed the construction of defilades at Fort Knox and recorded embankment construction methods. Construction practices were in accordance with the design guidelines. The defilades at Fort Drum and Fort Benning were most indicative of defilade conditions on high-use ranges. Figure 14 depicts two firing positions. The defilade on the left in Figure 14 uses an alternative blast mat of cabled concrete. The defilade on the right in Figure 14 uses no method of protection in the blast area and the resulting bare soil is shown.

Fort Drum, NY

Fort Benning, GA

The defilade design guidelines require revision in several areas. Emplacement guidelines for slope, slope length and weapons blast, alternative materials specifications, and erosion control practices were investigated to increase emplacement longevity. Defilade embankment faces are subject to repeated blast forces. The damage of repeated weapons discharge on embankments caused visible vegetation loss and unknown soil structure degradation as is shown on the right in Figure 14. Visible damage to the blast mat and the soil structure on protected embankments such as the defilade in the left image of Figure 14 were also apparent. Embankment design criteria for defilades should include consideration of blast wave effects.

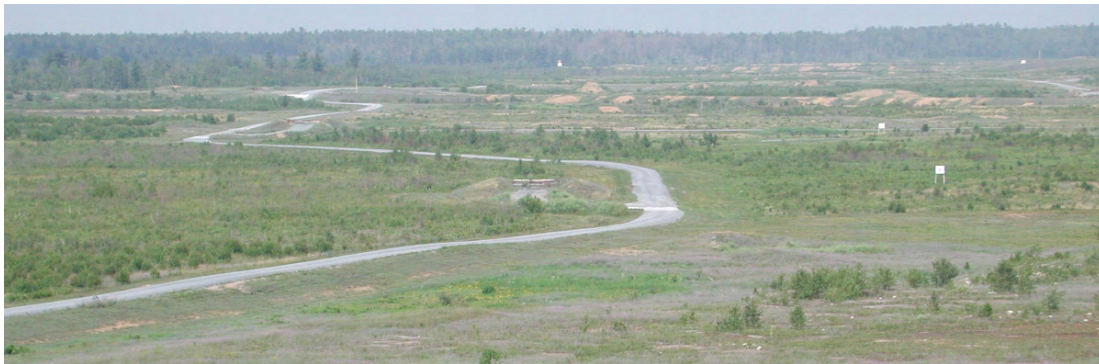
The dimensional characteristics of a firing or target structure are set by military equipment line-of-sight requirements and ranges must accommodate the capabilities of mechanized equipment. Engaging targets in a realistic manner requires range lengths several thousand meters in distance and elevated targeting structures. As a result of these requirements, berm heights can be quite substantial using line-of-sight analysis. Using standard range designs in the *RETS Range Design Manual*, sample berm heights were calculated. On level ground, embankment heights at the edge of a range can exceed 12 meters. An analysis of new DMPRC designs at Fort Benning found that the maximum berm height for moving embankments was 10 meters and that the embankment slope length was 31 meters. Berm heights of 10 meters in easily erodible sandy soil on highly used ranges present maintenance challenges. Eroded berm tops are the likely future result based on observations of current ranges. Figure 15 illustrates this phenomenon. Multiple exposed embankment target structures can be seen on this MPRC at Fort Drum. Denuded embankments diminish the value of the training experience by eliminating the element of surprise for military personnel that train on this facility multiple times. The use of sustainable range practices has the potential to reduce this problem. Topsoiling, mulching, and vegetation can enhance range structures and blend with the surrounding environment creating a more realistic training setting.

**Figure 15. MPRC at Fort Drum, NY.**

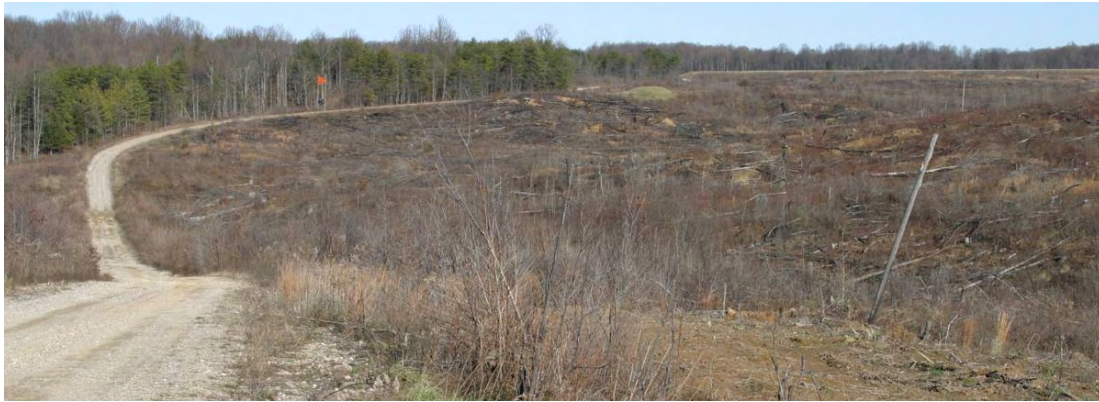
The research team observed and recorded the use of erosion control practices at the four installations. In general, a comprehensive erosion control plan was not used at installation ranges. Soil conservation structures such as check dams, sediment detention basins, rock riprap, grass-lined/rock-lined waterways, and low water-crossings were intermittently seen at ranges. These structures were discernibly placed to correct an existing problem such as severe erosion. These approaches, while beneficial and necessary, ideally should have been implemented before the damaging effects of erosion were apparent. An erosion control plan implemented during the construction phase of a range would minimize erosion maintenance expenditures. The MPTR region shown in Figure 16 is an outstanding example of the need for erosion control planning. During the construction phase of the range, large tracts of forested land were cleared for line-of-sight requirements. Unfortunately, a method to control erosion was not implemented. The steeply sloped landscape in Figure 16 has been severely eroded and would benefit immensely from the use of erosion control structures. Range officials at Camp Atterbury are now faced with long-term maintenance expenditures that would not be needed if an erosion control plan had been implemented initially.

Figure 16. MPTR, Range 37, Camp Atterbury, IN.

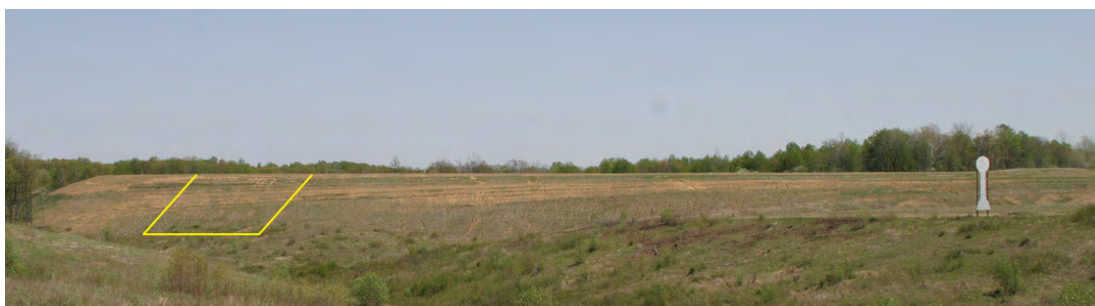
A moving target emplacement on Range 37 was chosen to monitor embankment face erosion. This embankment was selected on the basis of berm height, slope, and embankment slope length, 18 m (59 ft), 31 percent (3.2:1), and 64 m (210 ft), respectively. Additionally, it was decided that the low level of embankment face vegetation was characteristic of highly used range structures and would be representative of embankment erosion potential on other installations. A study plot was established on the embankment face in the area shown in Figure 18. The measurement of soil loss, soil movement, and soil deposition was monitored using a modified erosion pin method of Haigh (1977), Martin (1996), and the United Nations Food and Agricultural Organization (FAO 1997). This method is an effective way to quickly gauge the spatial characteristics of erosion on the embankment and determine overall soil loss from the field. The erosion pins were small stainless steel stakes 50 to 75 cm in length and 3 mm in diameter see Figure 19. Additionally, the stakes were graduated for easy measurement. Forty stakes were placed on the embankment face in a grid pattern like the one shown in Figure 19 to directly measure soil loss from the study plot. Measurement of soil movement was achieved using a graduated pin and periodically taking a digital image of each pin. The digital photographs, the small pin diameter, and the graduated markings on the erosion pins reduced soil disturbance in the areas surrounding the pin that would be associated with direct measurement. These images were catalogued and stored for later analysis of soil movement within the study plot.

**Figure 18. Erosion pin plot on moving target embankment.**

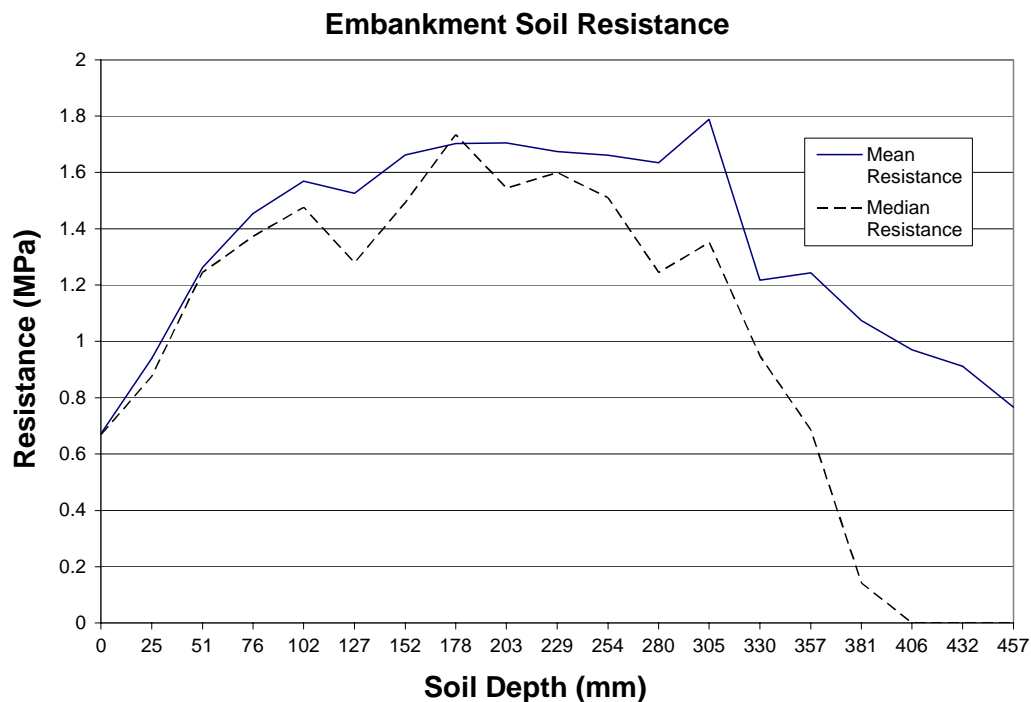
Figure 20 illustrates soil resistance data collected from the north embankment plot on 10 March 2004 at the onset of monitoring. Soil moisture analysis of samples taken at the time of testing indicated a soil moisture content of 14 percent by weight.

**Figure 20. Soil resistance data from embankment study plot.**

Soil penetrometer readings taken at 40 grid locations revealed surface and near-surface soil compaction. The mean soil resistance increased to a maximum 1.8 MPa (megapascals) at a depth of 30 cm and the median soil resistance increased to a maximum 1.7 MPa at a depth of 17.5 cm for the study plot. Soil compaction below 30 cm depth dropped dramatically in the soil for the median and the mean soil resistance. The measurements taken on this embankment suggest that adequate compaction did not occur in soil depths below 30 cm. This finding was unusual because soil resistance should remain constant or increase at depths greater than 30 cm. This indicates that, during construction, proper soil compaction was not achieved for this embankment.

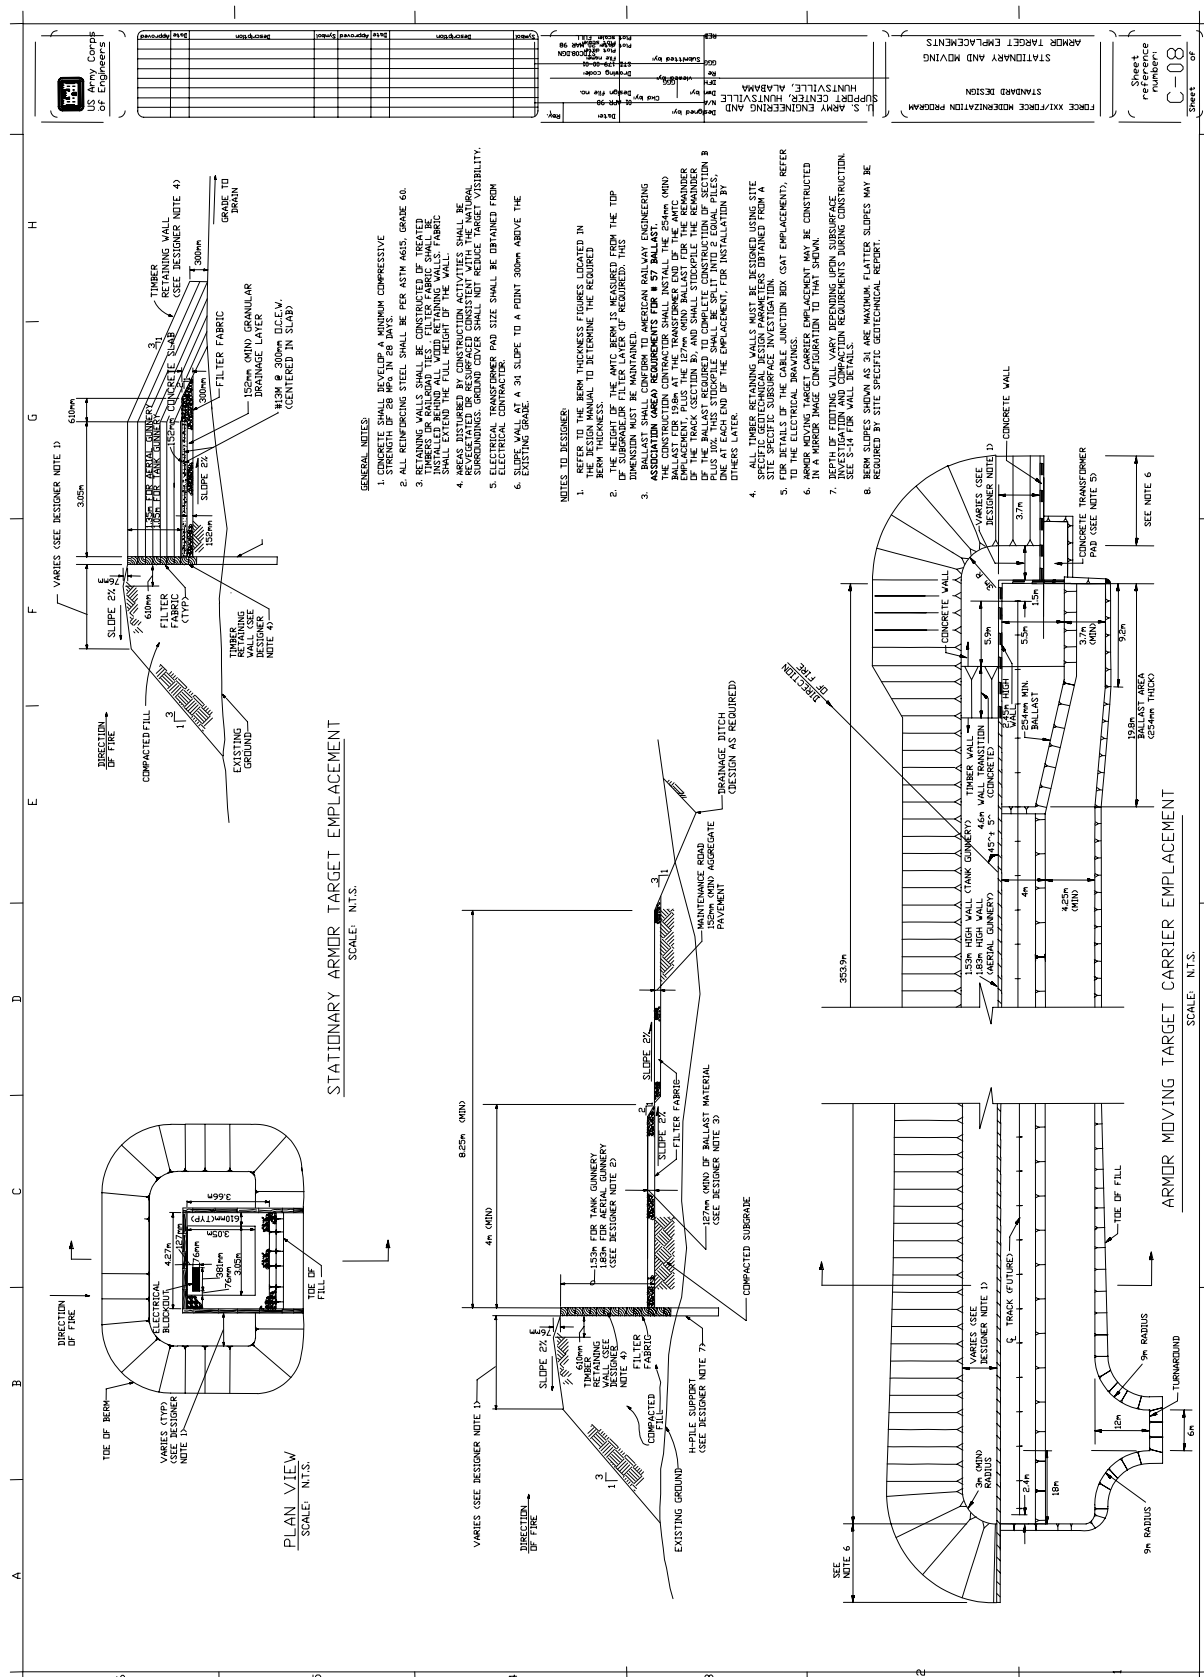
Figure A-1. Stationary and moving target emplacement designs for armored vehicles.

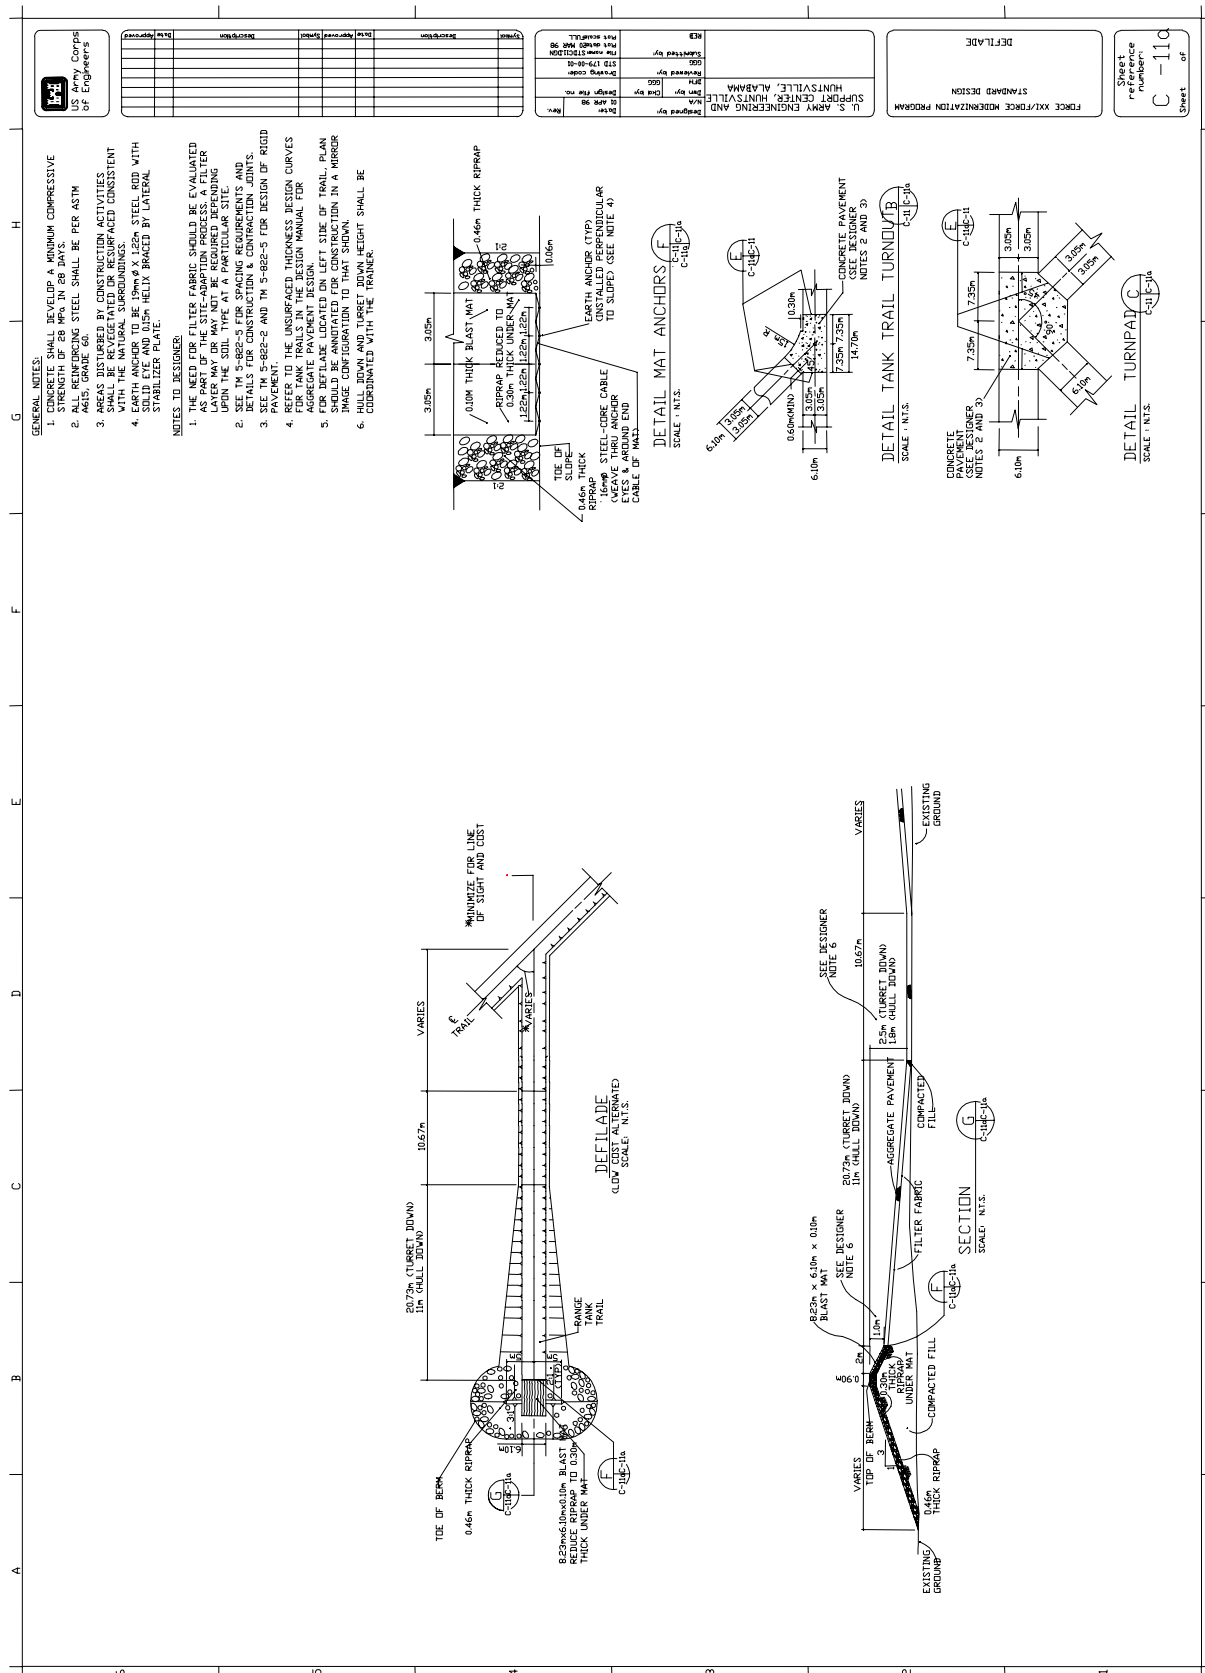
Figure A - 1. Low-cost defilade design for armored vehicles.

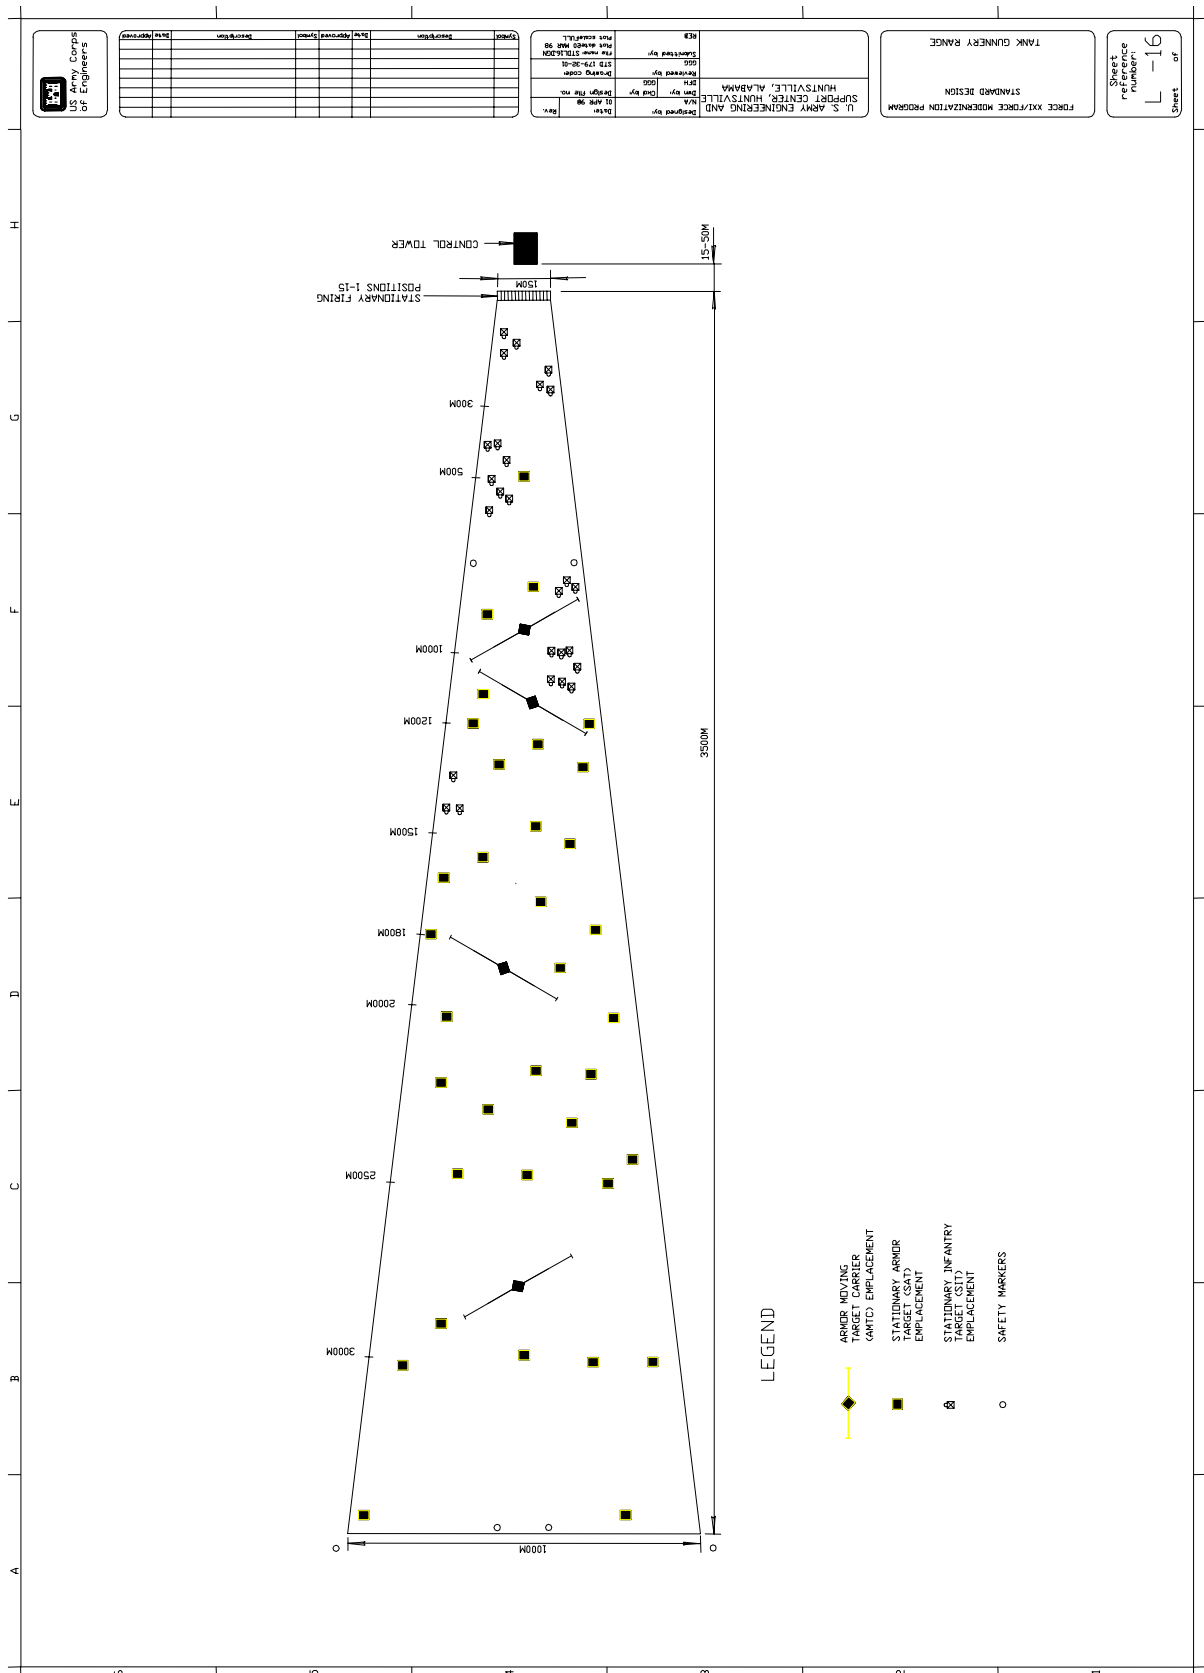
Figure A - 7. Tank gunnery range design layout.
